Building Number: 46

Original Name: Wastewater Treatment Plant
Sewage Plant

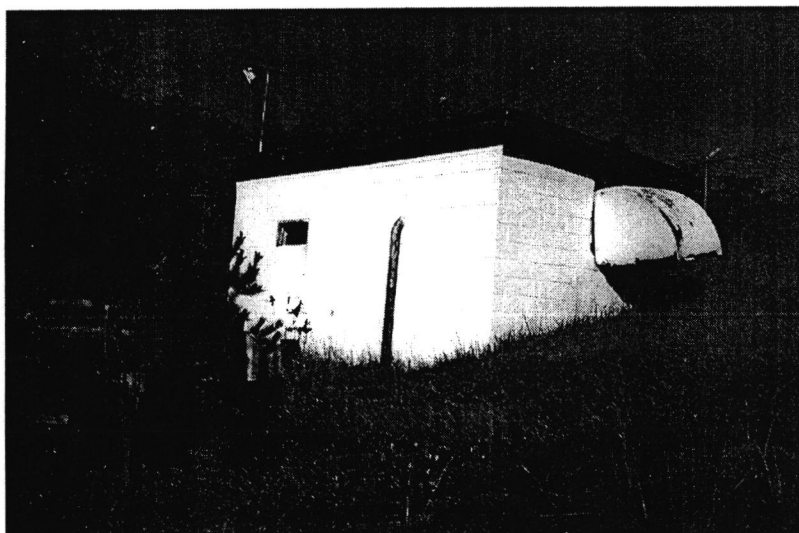
View from southwest.

Low pitch shed roof covered in rolled asphalt is in **fair/good condition**.

One-story rectangular structure constructed of CMU in **fair condition**. Two cracks in east wall need repair and all CMU needs repointing and repainting. CMU at vent opening needs repair/replacement. One entrance: paneled wood door with one lite in **fair/poor condition**. One small window opening is missing glass.

Wood window and door trim and wood fascia in **poor condition**. Wood is rotted and needs replacement. All paint is peeling.

Poured concrete is in **fair condition**.
